Conditions Assessment

SOUTH EGREMONT VILLAGE SCHOOL

June 2014

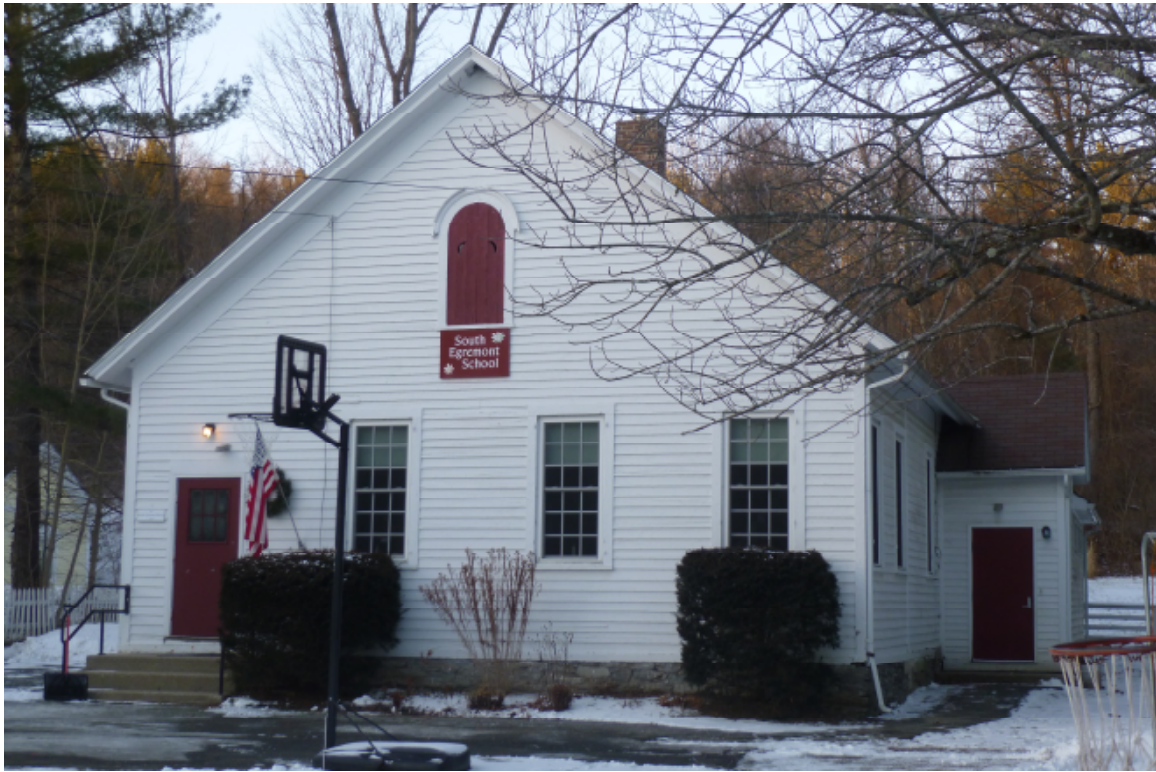
Image 2: The single Italianate window is the only design flourish in what is otherwise a purpose-built structure erected without stylistic considerations. The window is consistent with the building's 1880's origins. (South Egremont Village School, January 2014)

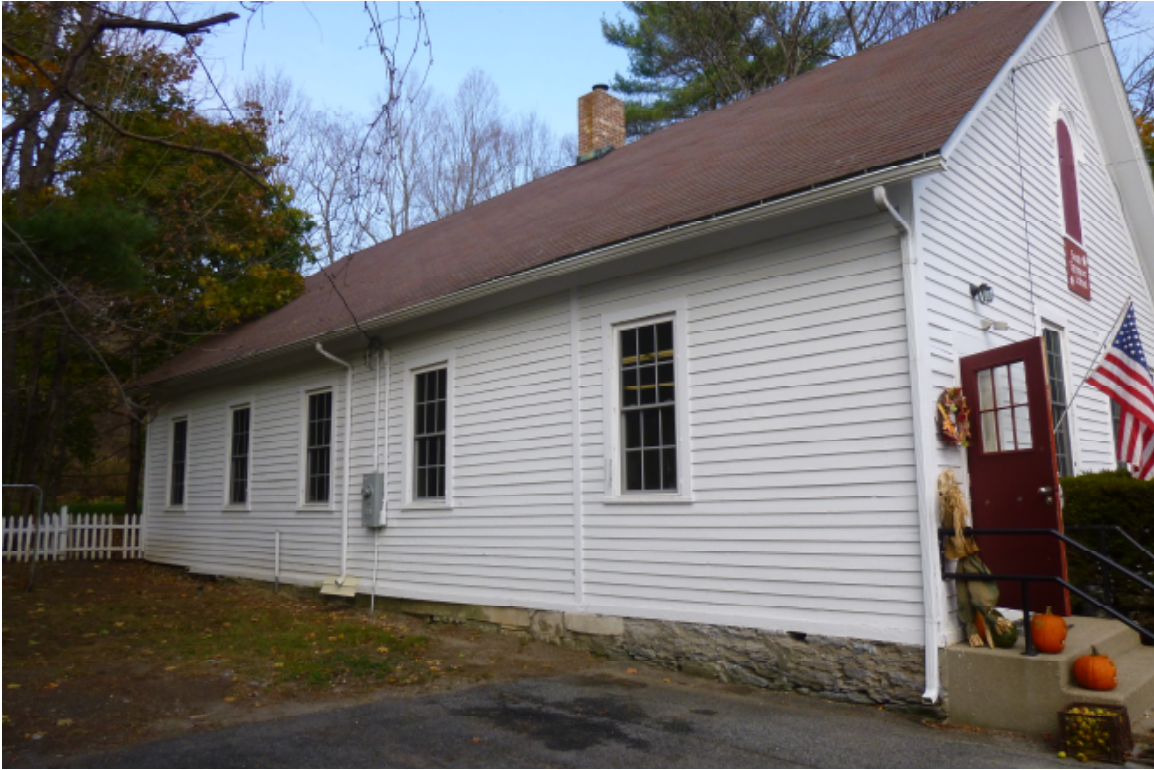
Image 3: At the same break in the foundation materials, there are vertical trim boards on both east and west elevations that break the continuity of the clapboards confirming the 10' addition to the south. (South Egremont Village School, January 2014)

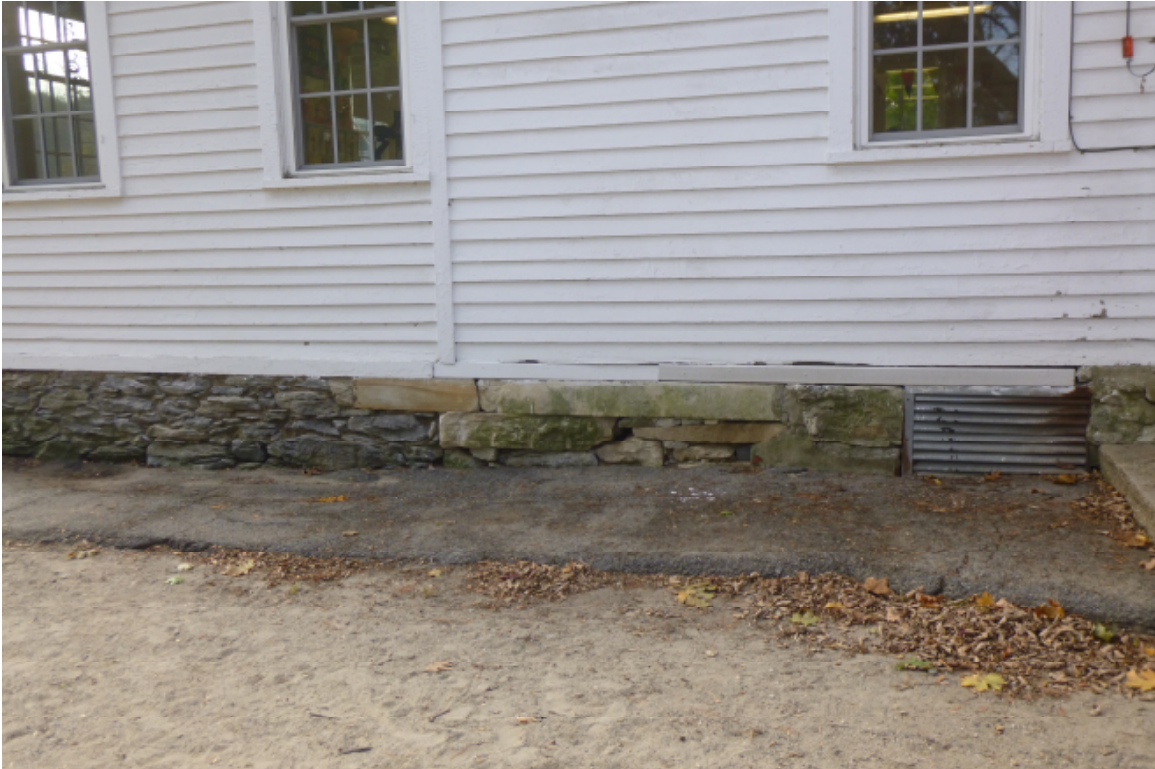
Approximately one-third of the top course of the west foundation wall has collapsed [Image 6]. The remaining stone foundation, with the exception of the south wall has little, if any, mortar left in the joints. The concrete east wall of the addition is severely eroded [Image 7]. The southeast corner of the sill is exposed where trim has deteriorated. [Image 8] There is significant deterioration in the rear one-quarter of the western wood sill and the sill is missing entirely at the northwest corner. The north foundation is not readily accessible without entering adjacent private property [Image 9].

Image 4: The foundation of the building is mortared stone. It is mostly field stone with salvaged white marble slab remnants in the rear three-quarters of the foundation.
(South Egremont Village School, January 2014)

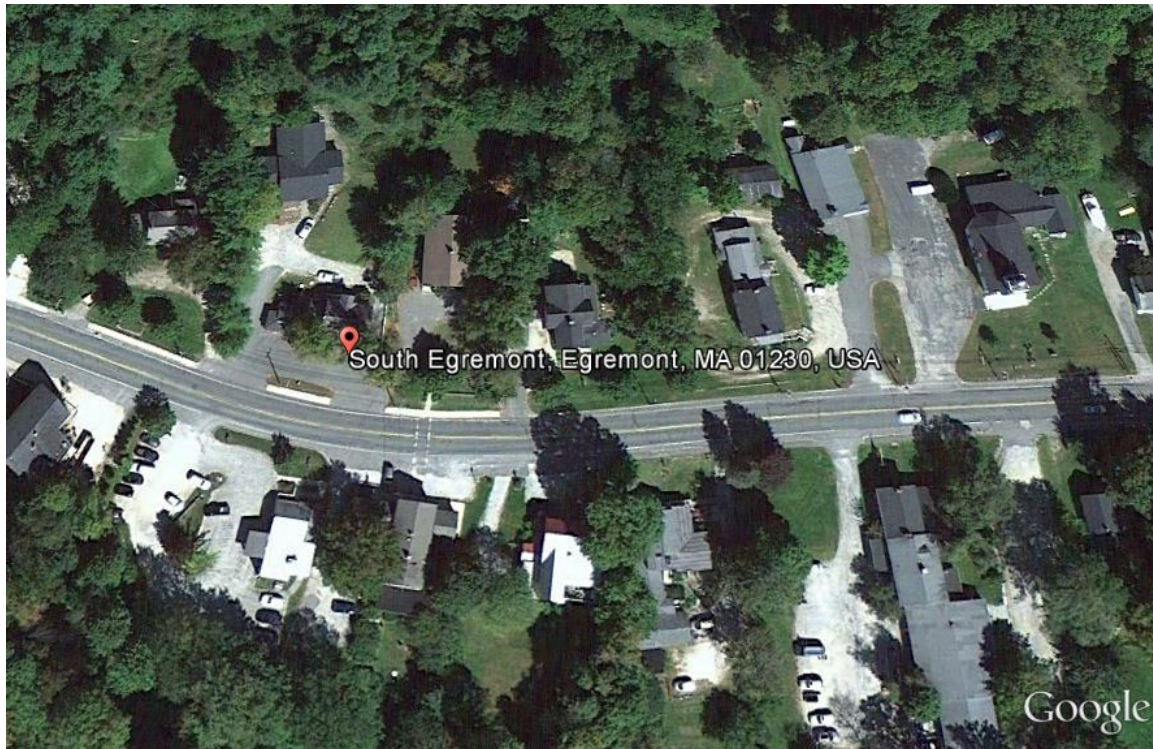
Image 5: The lot is bounded on all sides by fencing of varying styles. There is white picket fence at the front yard which runs parallel to the street. There are buildings directly to the east and west, and a small open yard that continues to rise more steeply to the north on an adjacent property. Trees from the adjoining lot are overhanging the north side of the building. The school is just to the northeast of the pin head. (South Egremont Village School, January 2014)

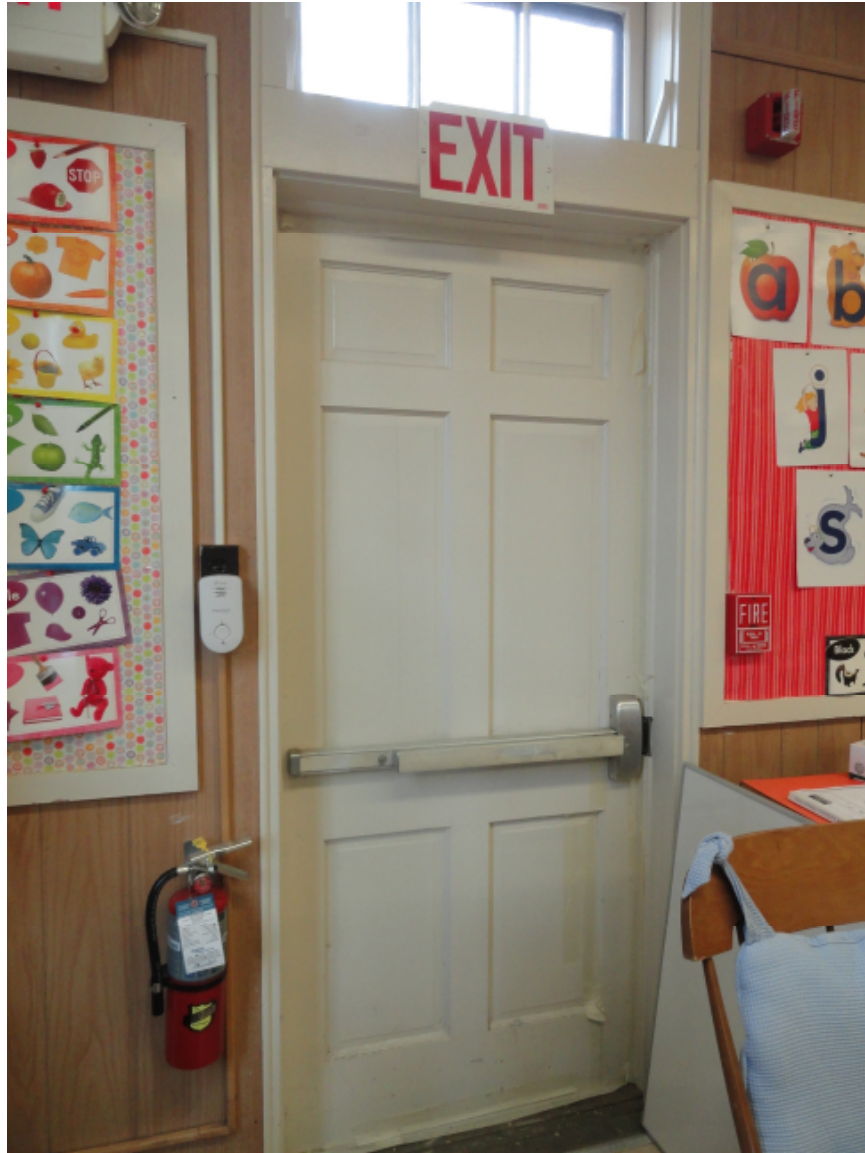
Image 17: The rear door and hopper style transom are very old. Even if they are not “original” they are part of the respectful changes and alterations that were made to the building over time and care should be taken to preserve them.
(South Egremont Village School, January 2014)

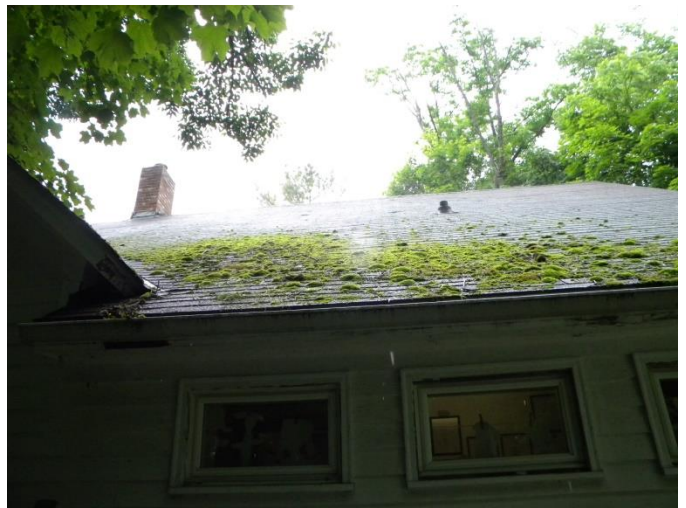
Roofing condition at east slope

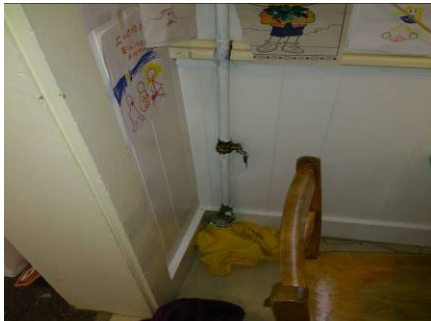
Domestic cold water piping enters the mechanical room from below is routed to the double sink, hot water heater and bathrooms. The piping is not insulated and runs exposed in the boy's bathroom. The piping appeared to be in good condition with no signs of deterioration/leakage.

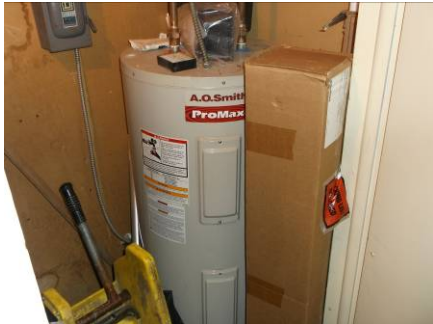
An electric domestic hot water heater is located in the storage closet. The electric heater is manufactured by A.O. Smith Company and has a capacity of forty (40) gallons. Domestic piping is copper and not insulated. The unit appears to be in good condition. Replacement is typically within ten (10) years.

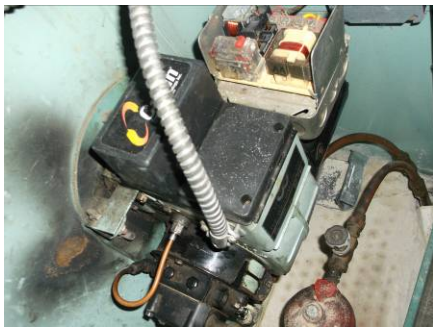
Fuel oil is provided by a underground fuel oil tank. The fuel lines are routed in the crawlspace to the oil burner. An line filter and shut off valve are present and appear to be in fair condition. Replace is warrented due to furnace change out.

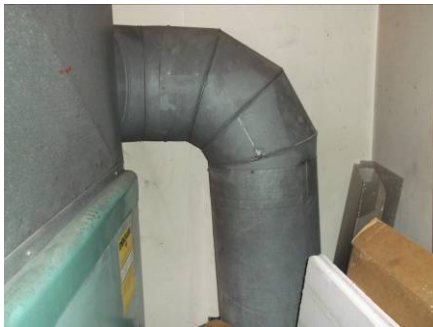
Combustion air for the furnace is provided by a duct that communicates with the crawl space below. No deterioration was present. Replacement is warranted due to furnace change out.

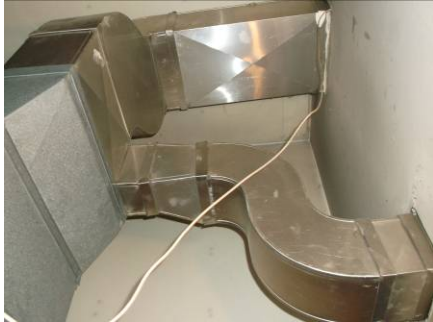
Metallic distribution ductwork from the furnace is routed to the classrooms and general areas. The supply and return ductwork mains off the furnace is non-insulated rectangular duct that directly feeds the diffusers. The return ductwork is exposed in the classrooms and appeared to be obstructed. Each duct appeared to be in good condition with no records or evidence of duct cleaning.

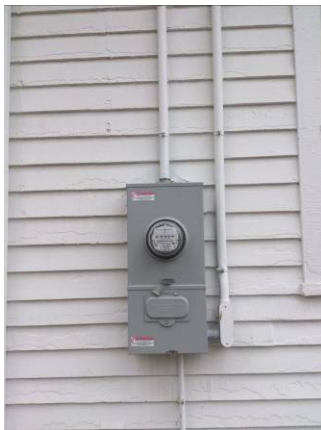
The electrical service entrance for the South Egremont School is located on the west side of the building. The service wires are routed overhead from a pole located on the adjacent property and from there to a utility pole on Main Street. The wires are connected to the service entrance conductors just below the eave. The wiring/conduit runs down the side of the building and terminates at a combination meter / service disconnect. The wiring/conduit then runs back up parallel to the service entrance wiring/conduit and into the building terminating at the electrical panel located in the copier room. The electrical service appears to be in good condition.

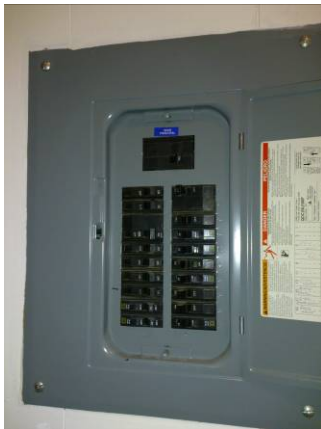
The electrical panel is a Square D QO load center rated at 100 amperes at a 120/240V, 1-phase, 3-wire voltage configuration. It is recessed into south wall of the copier room.

Dependent upon the actual amount of electrical load increase due to envisioned upgrades, the 100A electrical service rating for the building would appear to be adequate.

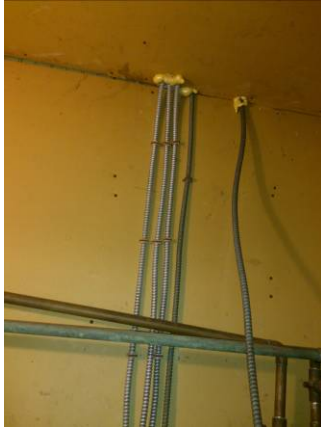
Branch circuit wiring consisted of armored cabling (AC) and non-metallic sheathed cable. The vast majority of the cabling was observed to be concealed behind finished surfaces. Electrical wiring was also installed in surface mounted raceway (wiremold) in a few areas.

It would appear as some of the branch circuit AC cabling has been updated in the past. The existing AC cabling is various ages and in good overall condition.

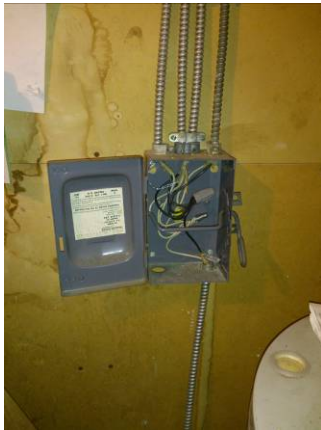
Also observed was an old disconnect switch enclosure located in the domestic water heater closet. This disconnect enclosure is currently being utilized as a junction box. The cover is not securely closed to prevent unauthorized access. Also one of the wire connectors outer plastic covering has broken off the wire. This disconnect should be removed and replaced with a proper junction box installed and the defective wire connector replaced as well.

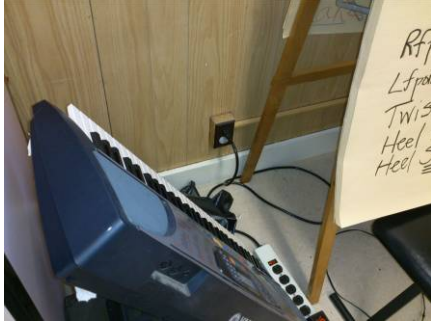
The receptacles within the building are type NEMA 5 duplex receptacles. The quantity is limited and the locations do not appear to be user friendly and therefore are causing the use of receptacle power blocks and extension cords to be utilized in a couple of areas. The few receptacles the building does contain are primarily recessed mounted with a few receptacles being installed in surface mounted raceway (wiremold). No receptacles were observed within the restrooms. The lone kitchen counter top receptacle was a

GFCI. No receptacles were observed in the domestic water heater closet or mechanical room.

The existing receptacles should be removed and replaced due to their age. Additional GFCI receptacles should be installed in the kitchen counter top, domestic water heater closet and mechanical room as well as an exterior weatherproof receptacle located near the proposed mechanical condensing unit to comply with current code. Tamper resistant GFCI receptacles should be installed in the restrooms to comply with current code.

The existing receptacles should be removed and replaced with tamper resistant receptacles. Additional tamper resistant receptacles should be added throughout the building in addition to the ones noted above to eliminate the use of receptacle power blocks and extension cords.

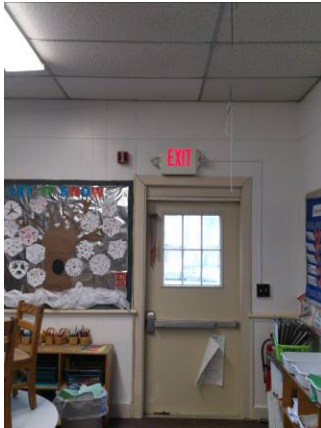
Light switches observed within the building appear to be a combination of surface mounted and recessed mounted devices. The condition varies between good to fair as it appears as some have been replaced. The switches are single pole and control the light fixtures within a respective room. Two switches located at the from exit door of the classroom control two rows of lights while a second bank of three switches located on the opposite wall control the remaining three rows of lights.

Additional single pole and three way switches and associated wiring/conduit should be installed so that lighting can be switched from all entry/exit points of the rooms.

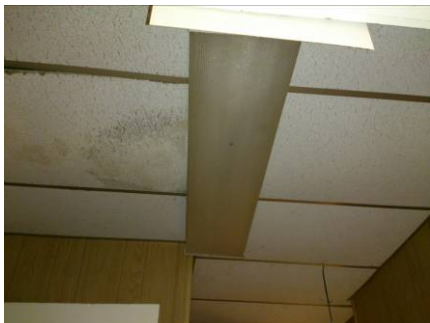
Lighting within the building consisted primarily of 1' x 4' surface mounted fluorescent light fixtures.

Storage rooms and mechanical room lighting consisted of ceiling or wall mounted porcelain socket fixtures utilizing compact fluorescent lamping.

Existing light fixtures are inefficient and at the end of their useful life expectancy. All lighting should be removed and replaced with new energy efficient fixtures. Exterior light fixture should be added to rear door.

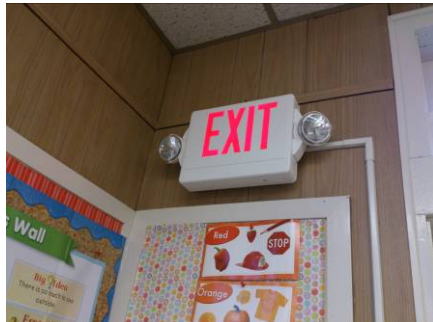
Emergency / Egress lighting in the building consisted of three combination emergency lighting / exit signs. One located above the front exit door, one located above the side exit door and one located adjacent to the rear emergency exit door.

The existing combination units have remote capacity and all three have a single remote emergency light head connected to them. These remote emergency light heads are located over each of the three exit doors of the building.

The combination emergency lighting / exit signs appear to be in good condition. However, the dual head lens require adjustment as one of the lens are pointing upward on a couple of the fixtures.

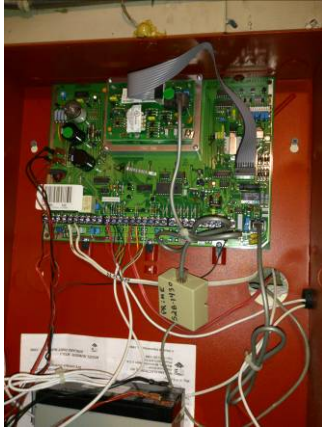
The fire alarm control panel (FACP) for the building is a combination fire alarm and burglary control panel located in the mechanical room. The fire alarm system appears to be a wired/wireless system consisting of two zones with an RF receiver mounted above the FACP. Zone one monitors the smoke detectors and zone two the heat detectors.

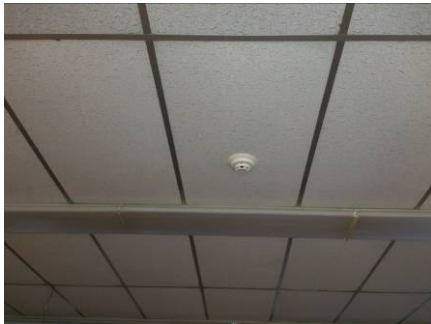
Detection devices consisted of smoke detectors located in the classroom, kitchen and copier room. Heat detectors were located in the restrooms, mechanical room and domestic water heater closet.

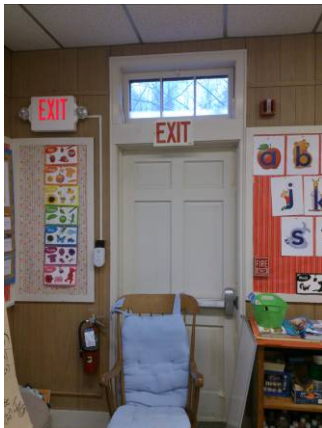
Initiation devices consisted of pull stations located adjacent to the front and rear exit doors and one located in the side door hallway near the exit door.

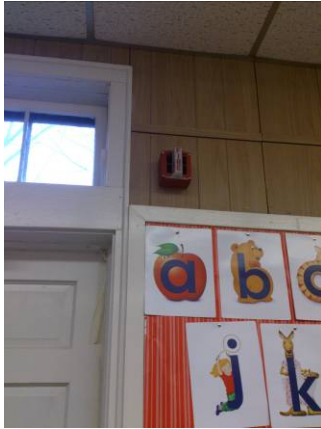
Notification devices consisted of horn/strobes located in the restrooms, classroom and kitchen. The restrooms horn/strobes are to have been installed in the last few years. The remaining horn/strobes see to have been in place a number of years.

Also observed was a plug in carbon monoxide detector. This detector is located adjacent to the rear exit door.

No fire department knox box was observed.

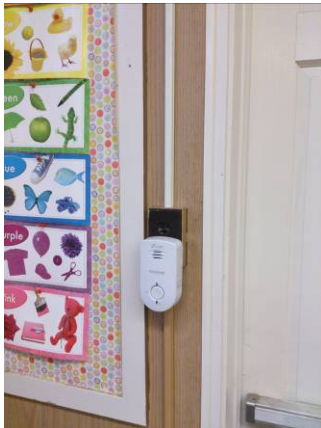
The FACP and detection devices appear to have been in place ten to fifteen years with the notification devices in the classroom and kitchen fifteen to twenty. The system seems to be in good to fair condition dependent upon device but is at the end of its useful life expectancy. The system should be removed and replaced with additional detection and notification devices added.

Carbon monoxide detectors connected to and monitored by the fire alarm system should be incorporated into any fire alarm system upgrade. In the interim, carbon monoxide detectors should be installed within the mechanical room to provide the earliest possible alarm.

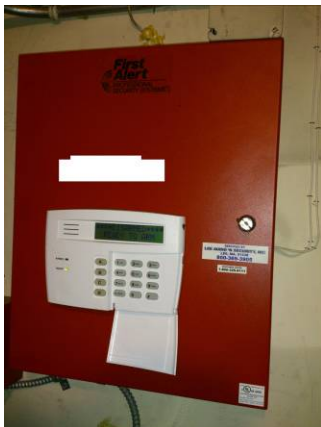
The FACP is a combination fire alarm and burglary control panel and is monitoring the security system as well. The keypad for the security system has been mounted to the FACP enclosure door.

It appears as the security system consists of door contacts. No motion or break glass detection devices were observed.

The security system appeared to be in good condition. Consideration should be given upgrading the system to allow for the installation of motion detection and break glass sensor

devices. The arm/disarm keypad should be located at one of the two entry doors in lieu of the mechanical room.

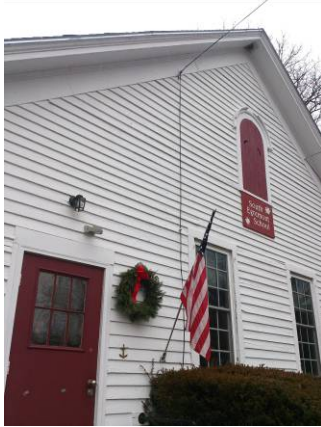
The building contained two different telecommunications systems. It appears as standard telephone wiring is routed overhead from a utility pole on Main Street and down the front and into the building. It seems as this service is for the telephone system for the building only with the wiring extending from the system network interface boxes to telephone jacks located within the building. The telephone jacks are located in inconvenient locations and the wiring is not properly secured in place in some instances. Telephone jacks were also located in the FACP for the fire alarm and security system monitoring.

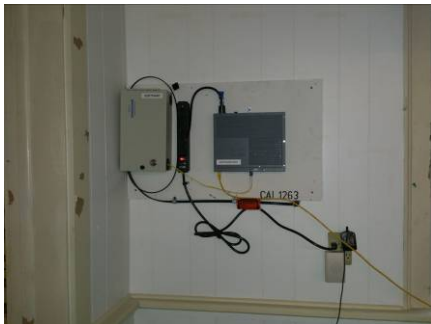
The second telecommunications system observed is a broadband high speed internet system. Wiring is routed overhead from a utility pole on Main Street to the front of the building. The wiring then follows the eaves of the building and then down the side of the building near the side entry door and into the building.
